Manhole Inspection Summary

Manhole # S37Y1_022MH

Location Address: **3715 2nd St**

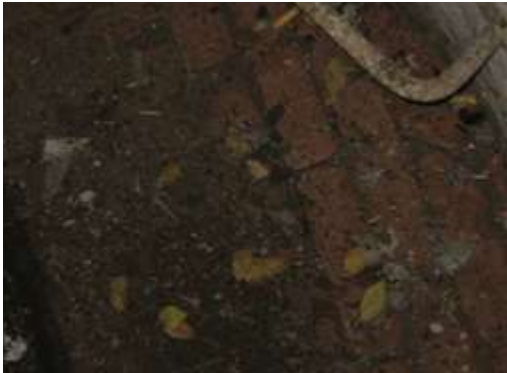
Defect 2

debris

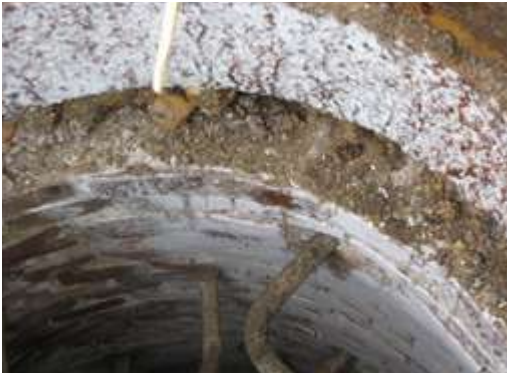
Defect 1

Offset: **2** (in.)

frame offset

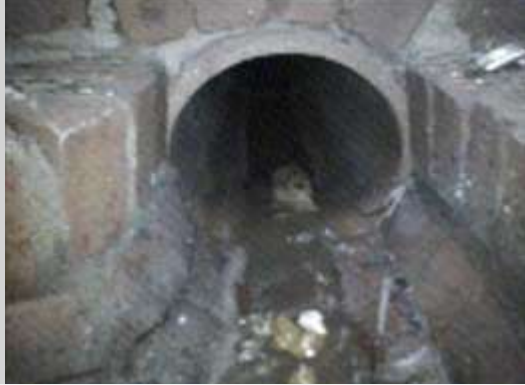
12 O'Clock Outflow

8 in. Circular Gravity Sewer
Pipe Out @ 12 O'Clock

Pipe Height: **8.4** (in.) Rod and Bar (Angled)
Pipe Material: **Clay** ☐ Pipe Lined
Invert Depth: **9.76** (ft.) Flow Characteristics: **Fast**
Deposits: ☒ None ☐ Mud ☐ Sludge ☐ Debris ☐ Grease
Silt Depth: (in.) Deposits Extent:
Infiltration: **None** Pipe Seal Cond: **Sound**

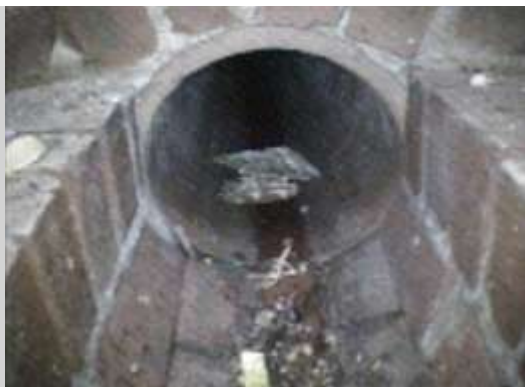
6 O'Clock Inflow

8 in. Circular Gravity Sewer
Pipe In @ 6 O'Clock

Pipe Height: **8.4** (in.) Rod and Bar (Angled)
Pipe Material: **Clay** ☐ Pipe Lined
Invert Depth: **9.09** (ft.) Flow Characteristics: **Fast**
Deposits: ☒ None ☐ Mud ☐ Sludge ☐ Debris ☐ Grease
Silt Depth: (in.) Deposits Extent:
Infiltration: **None** Pipe Seal Cond: **Sound**

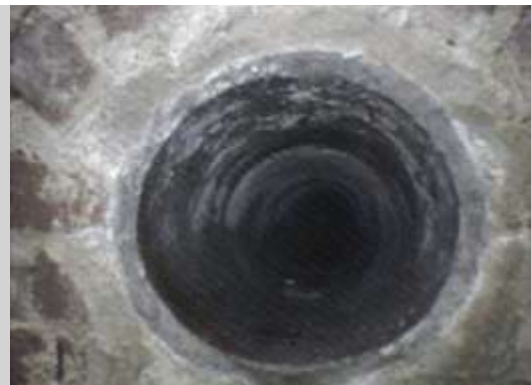
9 O'Clock Inflow

Pipe In @ 9 O'Clock

Pipe Height: **8.4** (in.) Rod and Bar (Angled)

Invert Depth: **7.06** (ft.) Flow Characteristics: **Slow**

Infiltration: **None** Pipe Seal Cond: **Sound**

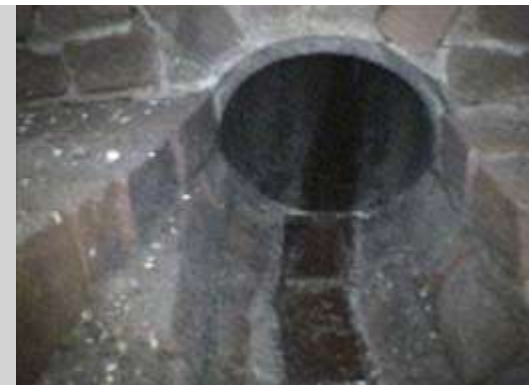
Drop In @ 9 O'Clock

Drop: Outside	Rod and Bar
Angled: Yes	Reading: 7.94 (ft.)
	Inv Depth: 8.94 (ft.)
Drop Condition: Open
